# REPORT OF MARINE SURVEY

***“Fantasy”***  
63' CHEOY LEE  
MOTORSAILER

Ariel Cabrera  
Independent Marine Surveyor  
Society of Accredited Marine Surveyors®  
Accredited Marine Surveyor®

Friday, July 6, 2012

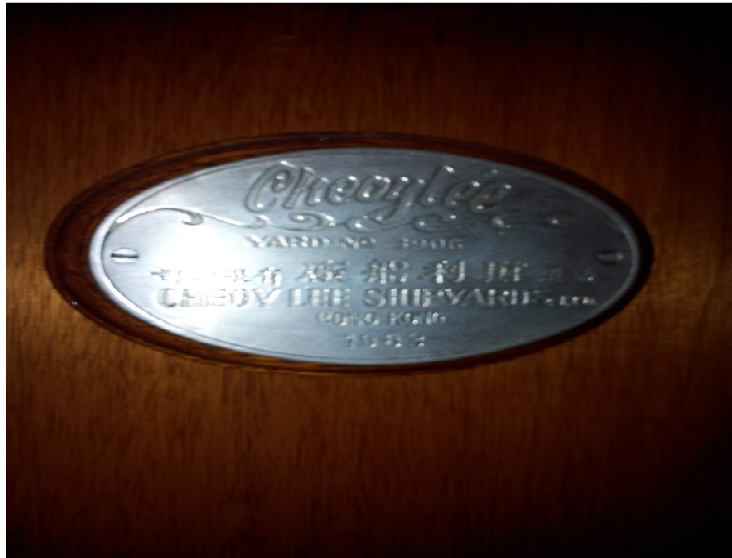
HIN # 948541

HIN number could not be verified at Transom.

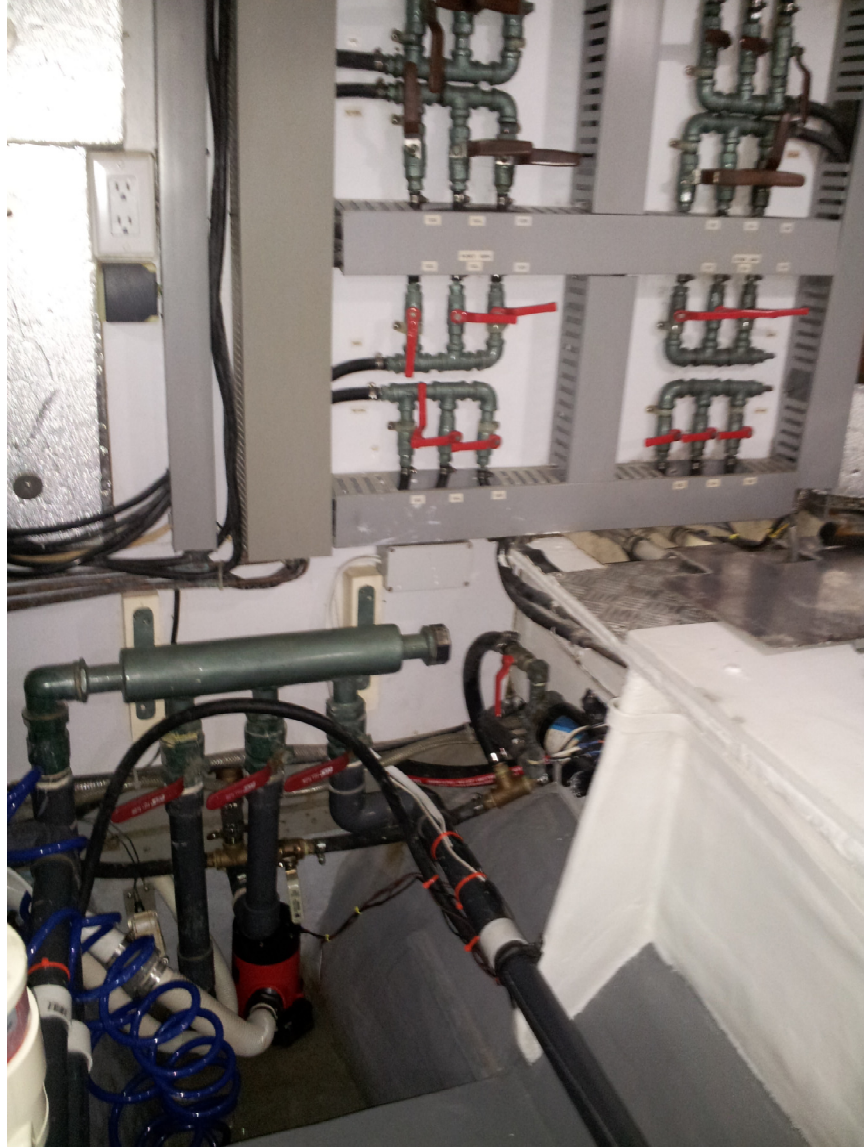
Pictured Above: Fuel valve selector switches (upper right), and 3-way PVC outflow bilge emergency crash pump (w mesh strainer) connected directly to diesel CAT engines. All handles labeled and in good condition.
